Our Ref: MLC 1452

Date: 06/03/2019

Re: View to Purchase Inspection of Ford Transit Van

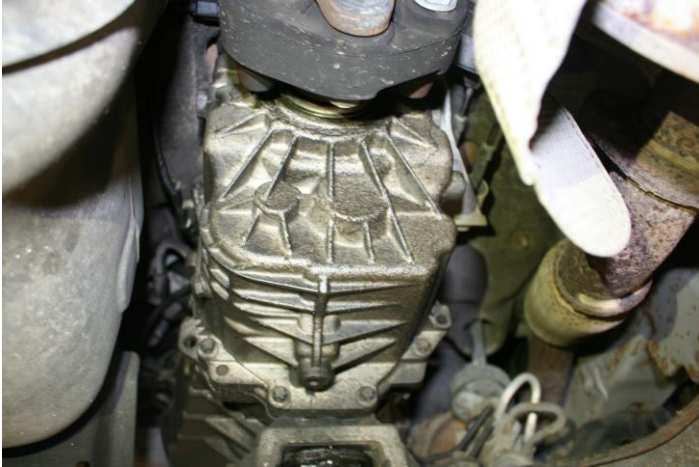
The writer did note that the gearbox housing did appear somewhat damp; however there are no obvious leaks evident. There is an oil drip to the rear of the engine oil pan.

Photo no.3 is a view of the damp gearbox housing.

There is an oil leak evident to the rear of the engine oil pan with a dampness to the gearbox bell-housing. The engine fan belt is perished and requires replacement. Wiper blades require replacement. Overall the vehicle requires a service.

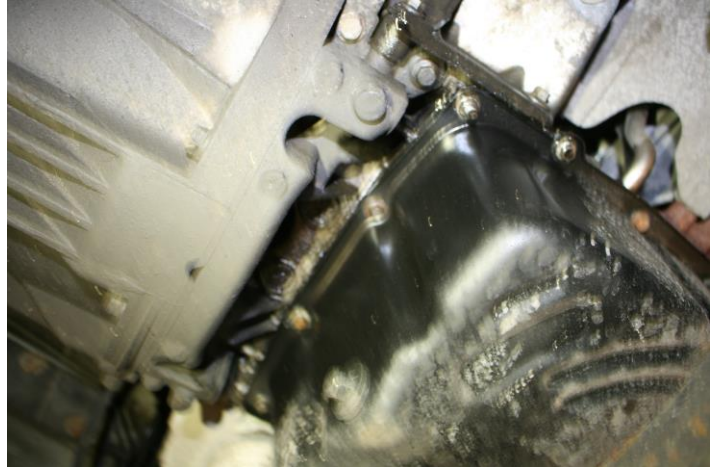
Photo no.4 confirms the rear section of the oil pan wet from oil.

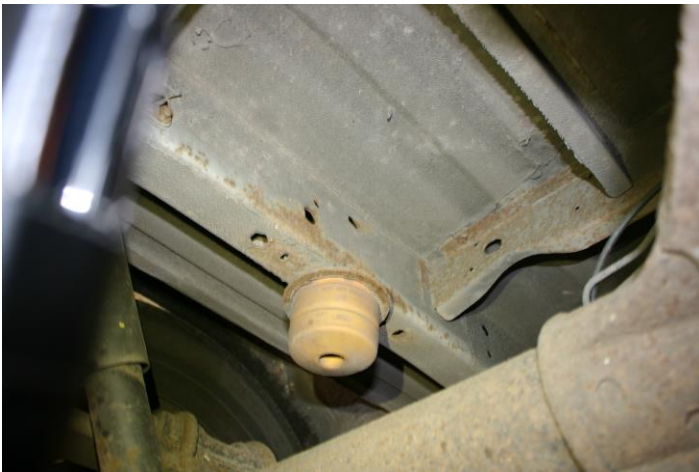
The undercarriage has extensive surface rust evident; however in its current condition there are no repairs necessary as per C.V.R.T. requirements.

Photo no.5 is a common area for C.V.R.T. detection of corrosion on the O/S/R chassis bump stop area.

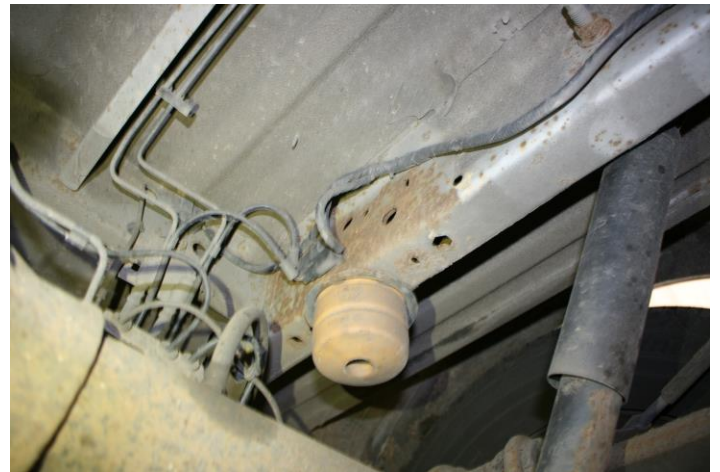
Photo no.6 is a common area for C.V.R.T. detection of corrosion on the N/S/R chassis bump stop area.

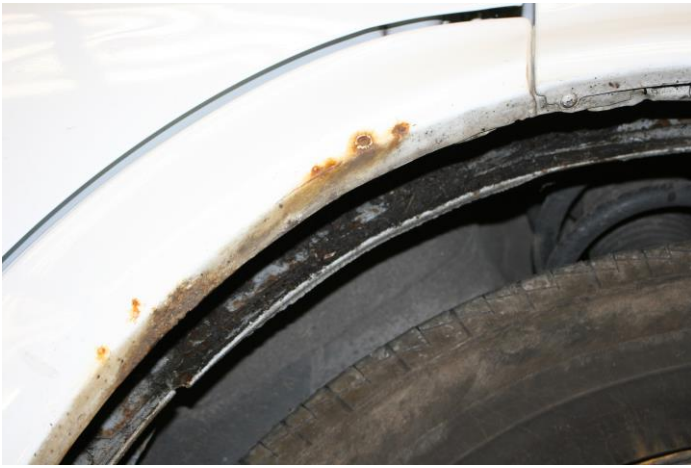
The side panelling of the vehicle has numerous indentations. There appears to be no previous body repairs carried out. The O/S/F wheel arch is showing signs of surface rust and oxidation of the panel.

Photo no.7 is a view of the surface rust to the O/S/F wheel arch panel with oxidation of the panel evident.

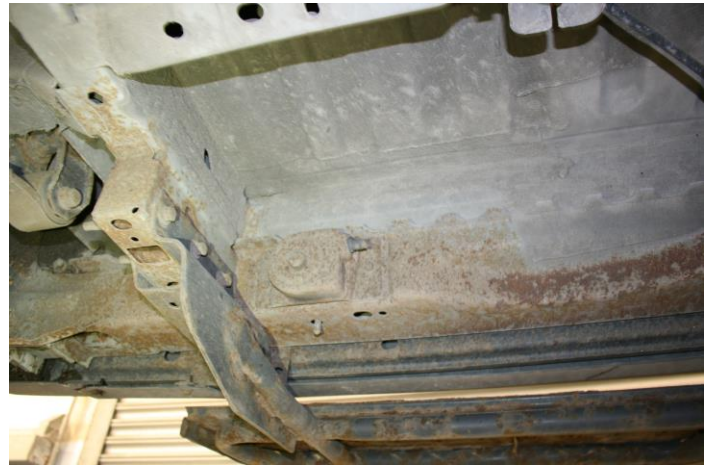
Photo no.8 is a view of the rear end chassis cross-member another common area for C.V.R.T. detection of corrosion.
